TECHNICAL BULLETIN 26

Criteria for Replacing Fuse Plates after a Severe Earthquake

Paul Richards, PhD, PE¹

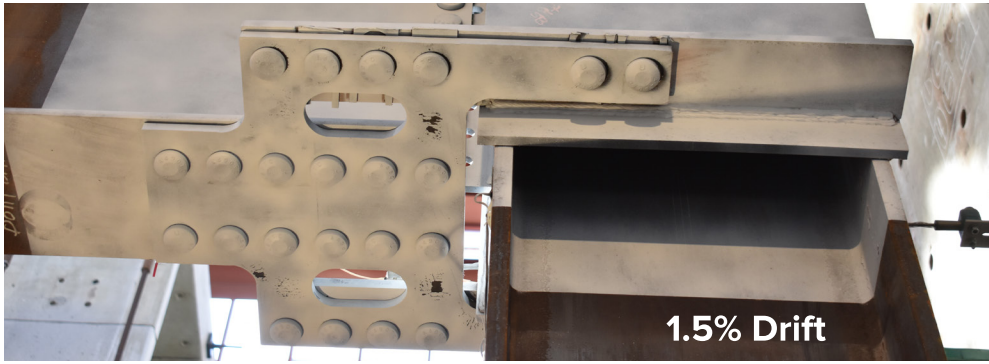
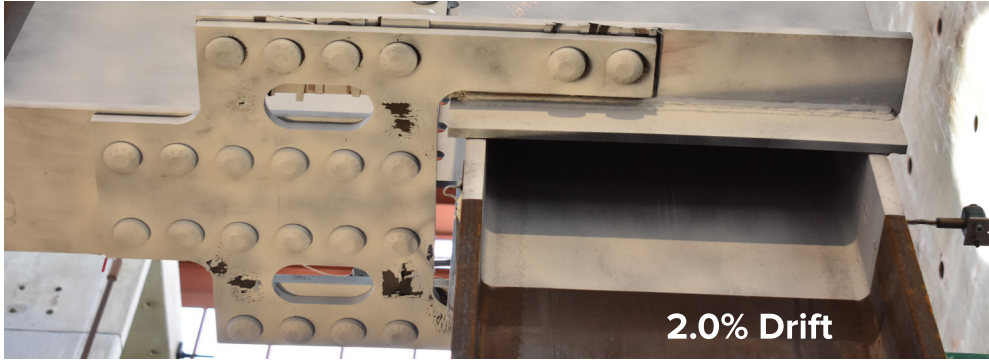
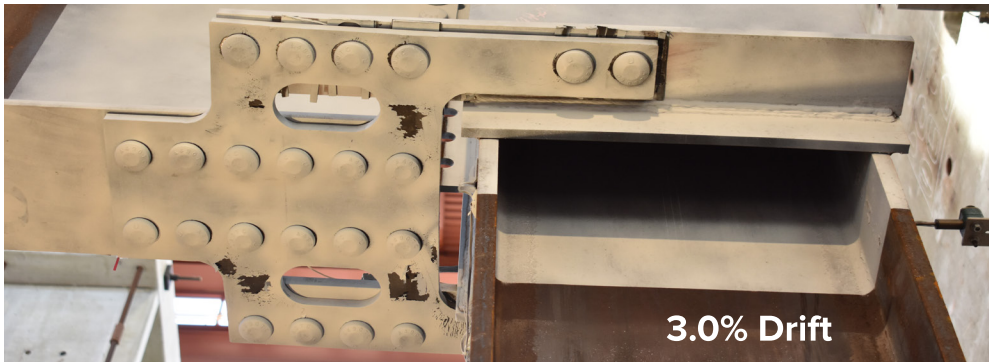
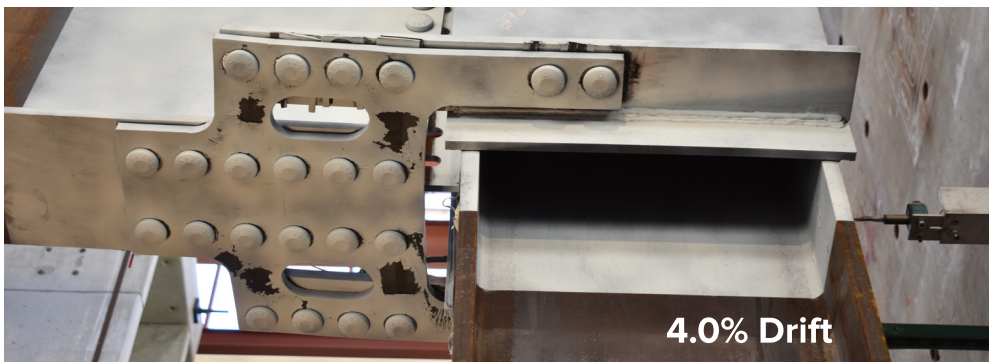
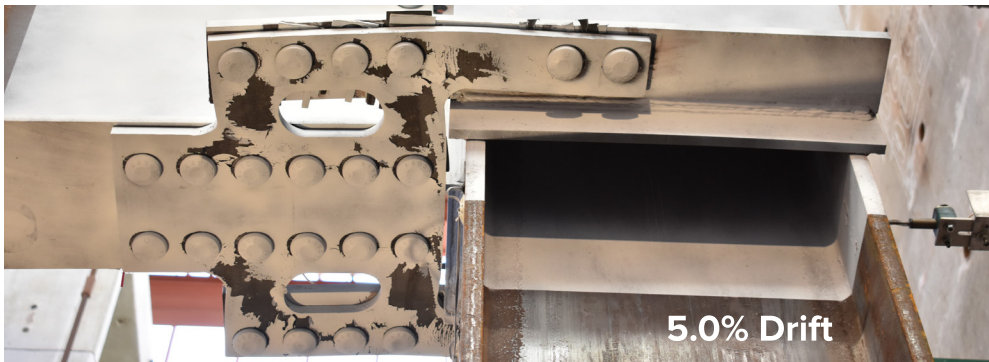
If residual drifts are not impacting building service, fuse plates should still be inspected after a design-level earthquake and checked for evidence that the story experienced drifts in excess of 4%. Figure 2 shows typical fuse plate yielding at different levels of story drift (Richards 2022). Flaking of the mill-scale on the fuse plate is evidence of the extent of fuse yielding and the amount of strain hardening in the primary yielding regions. Comparing the mill scale flaking with Fig. 2 can provide an estimate of the drift that the story experienced. If flaking suggests that the drifts exceeded 4%, then the fuse plates in that story should be replaced.

Fig. 2 Mill scale flaking corresponding to different levels of story drift (Richards 2022).

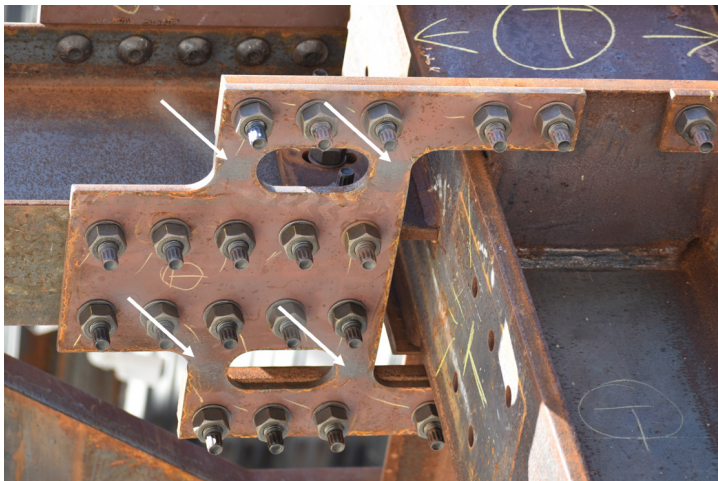
Inspection of the building after the completion of testing did not indicate residual drifts that would impact building service. The fuse plates in the bottom stories showed evidence of yielding (Fig. 3), but not evidence that the story drift exceeded 4%. Mill flaking suggested a maximum story drift of about 2% (compare Fig. 3. with Fig. 2), which is similar to what was measured by the instruments during testing. Fuse plate replacement would not be required under these circumstances.

Fig. 3 Mill scale flaking consistent with about 2% story drift.

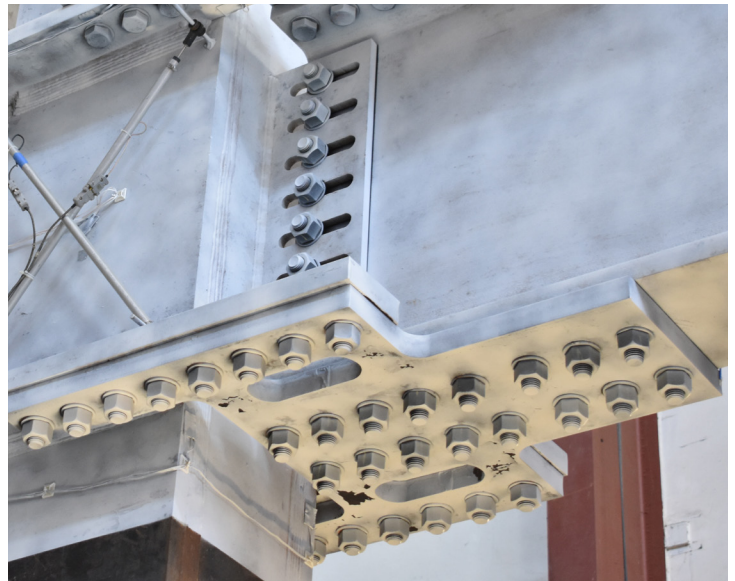
(a) after Northridge

If the fuse plate had been inspected after the Northridge loading, the estimated maximum drift based on mill scale flaking would have been about 2%, which is consistent with what was measured during testing. The flowchart (Fig. 1) would indicate that the fuse plate would be fine without replacement. If the fuse plate had been inspected after the Loma Prieta loading, the estimated maximum drift based on mill scale flaking would have been about 2.5% which would have suggested the fuse plate was good for at least another design earthquake without replacement. The successful subsequent testing with the Kobe loading proved that correct.

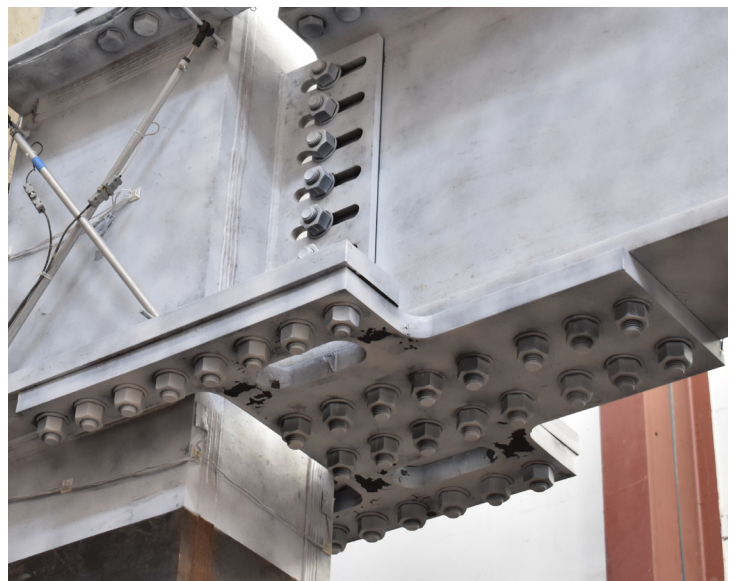
(c) after Kobe

Looking at the fuse plate after the Kobe loading, the mill scale flaking suggests story drifts around 4% were reached, which is consistent with what was measured by the instruments. This level of fuse plate yielding and hardening makes the fuse plate questionable for future events, and it should be replaced (Fig. 1).

Fig. 4 Mill scale flaking for MCE tests in sequence. (Lee and Uang, 2021).
