# TECHNICAL BULLETIN 14

## Using DuraFuse Frames in Seismic Retrofit Applications

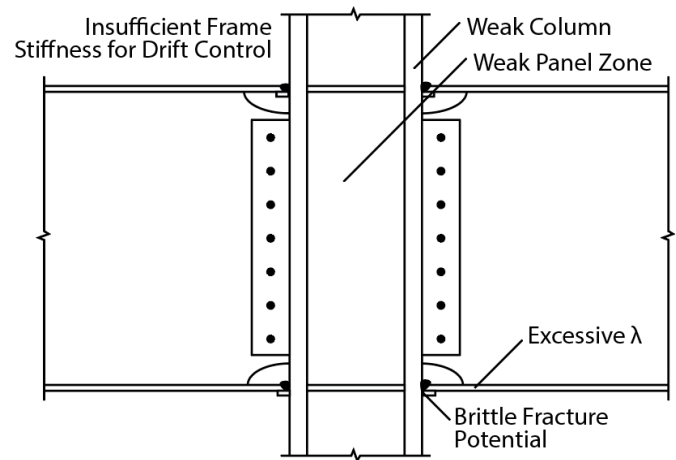
**Fig. 2** Case study joint from SAC pre-Northridge study building (*FEMA-355F*)

**Brittle weld detail** – The weld detail had the typical pre-Northridge connection. The weld tab for the bottom flange was left in place and the bottom flange was susceptible to brittle fracture.

**Weak panel zone** – The panel zone shear demand corresponding to beam plastic hinging was 1740 kips. The panel zone shear capacity, calculated per AISC 360 J10.6 (2016a) was only 948 kips. The incredibly weak panel zone would experience severe inelastic deformation that would preclude beam plastic hinging.

**Weak-column strong-beam** – The flexural demand on the column corresponding to beam plastic hinging was  $\Sigma M_{pb}^* = 5218$  k-ft. The column flexural capacity was  $\Sigma M_{pc}^* = 4201$  k-ft. The ratio of column strength to beam strength was 0.8, indicating that the column would form plastic hinges before the beams, and that the joint would not satisfy the beam-to-column relationship.

**Insufficient Stiffness** – More stiffness was desirable for controlling drifts.

**Beam flange width-thickness ratio** – The width-thickness ratio for the beam flange was 7.86 which was above the  $\lambda_{hd}$  limit of 7.34.

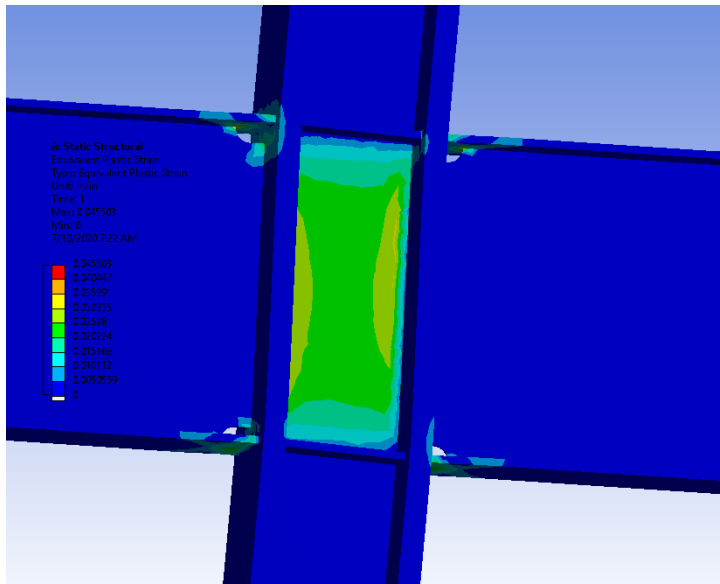
**Fig. 3** Plastic strains from finite element analysis of case study joint prior to retrofit (4% drift)

Fig. 3 shows results from finite element analysis of a sub-assembly with the connection at 4% drift, assuming that brittle fracture did not occur. As expected from the calculations above, only limited yielding occurs in the beams while severe inelastic deformation is imposed

on the column. These results represent a best-case scenario; a more likely scenario is that the bottom beam-to-column welds would fracture.

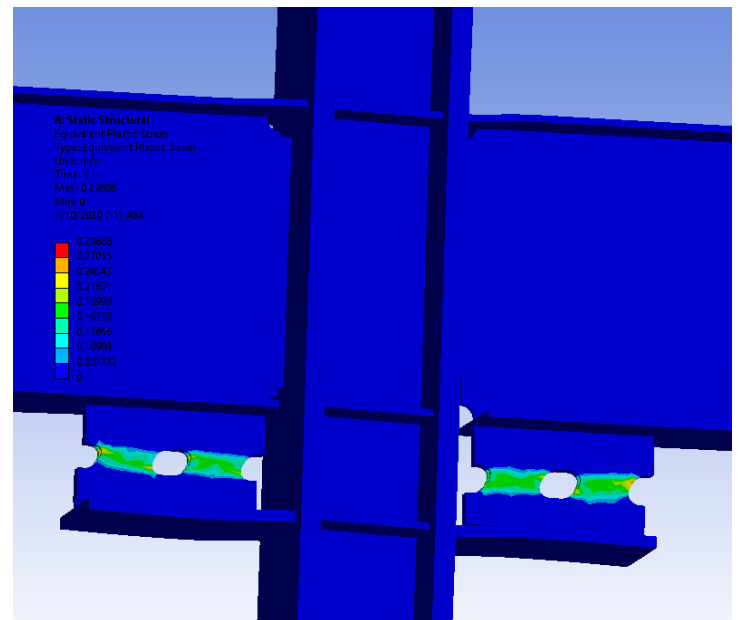
**Fig. 5** Plastic strains from finite element analysis of case study joint after retrofit (4% drift)

Figure 5 shows results from finite element analysis of a sub-assembly with the retrofitted connection at 4% drift. Inelastic deformations are limited to the fuse plates. The connection is able to achieve 4% drift without any yielding in the column or in proximity to the welds.
