# TECHNICAL BULLETIN 11

## Post-Earthquake Evaluation of a Building with DuraFuse Frames

**Abstract:** The March 18, 2020, earthquake near Salt Lake City, Utah, caused strong shaking at a site where a DuraFuse Frame building was under construction. The building was the new Student Center for the Salt Lake Community College (SLCC) Jordan Campus. A post-earthquake evaluation of the steel frame confirmed perfect performance of the DuraFuse Frames DF360 system during the event, with no damage to the steel frames. DuraFuse Frames systems are the most resilient steel moment frames available.

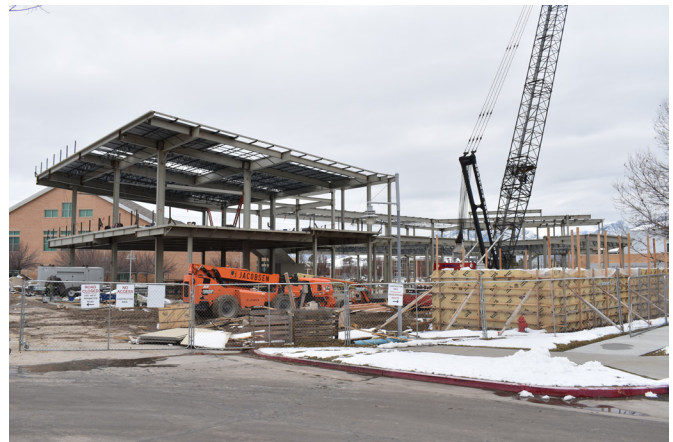
**Fig. 2** Level of completion at SLCC Student Center, March 6, 2020

The new Student Center at SLCC Jordan Campus was under construction at the time of the earthquake. Figs. 2 and 3 illustrate the stages of completion in March, 2020. At the time of the earthquake, the steel framing was completed and floor slabs had been poured.

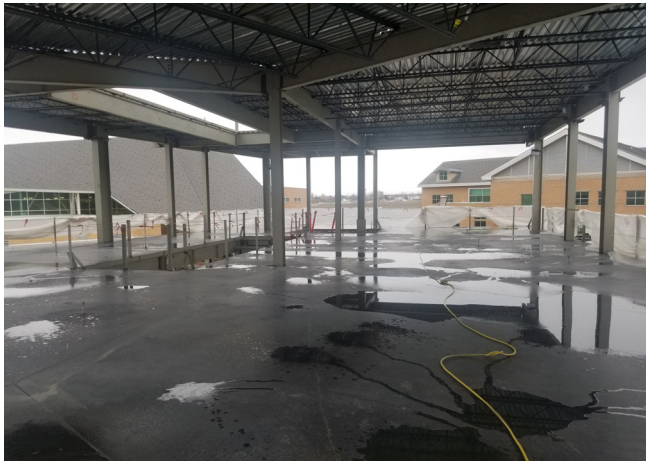
**Fig. 3** Level of completion of SLCC Student Center on March 18, 2020 (second floor)

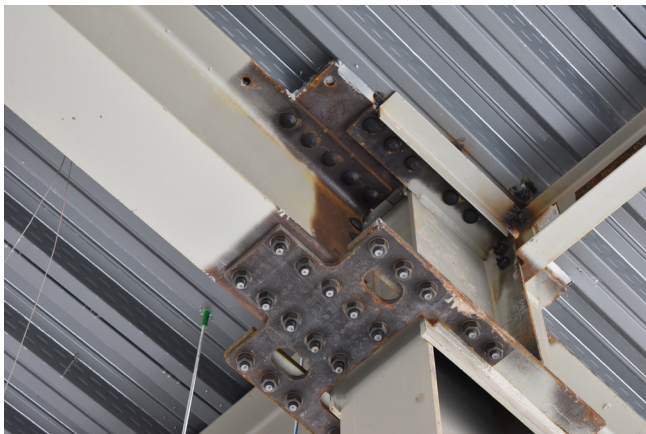
Four hours after the M5.7 event, Dr. Paul Richards (DuraFuse Frames) and Graham Oxborrow (Reaveley Engineers) performed a visual inspection of the structural frame for the SLCC Student Center. All of the DuraFuse Frames DF360 connections were visually inspected. There were no indications of column yielding, beam yielding, fuse plate yielding, bolt slip, or weld distress at any of the connections. Fig. 4 shows one connection.

**Fig. 4** DuraFuse Frames DF360 connection with no damage after M5.7 earthquake
