TECHNICAL BULLETIN 25

Shake Table Testing of DuraFuse Frames

Paul Richards, PhD, PE¹

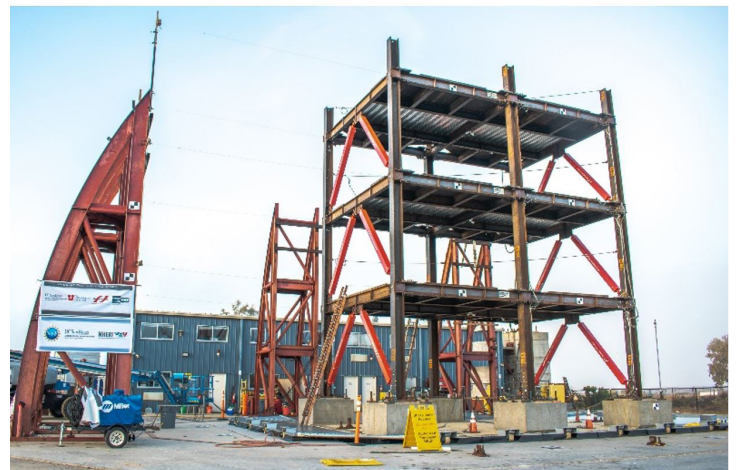
Fig. 1. The upgraded shake table at UCSD with the modular testbed building.

was proposed by Tara Hutchinson (UC San Diego) and Chris Pantilides (University of Utah) that could be used as a structural frame for various types of projects on non-structural components. They called it the Modular Testbed Building (MTB2), and one requirement was that it could easily be repaired following severe earthquake shaking. Figure 1 shows the table and MTB2 when the upgrades were completed in April 2022.

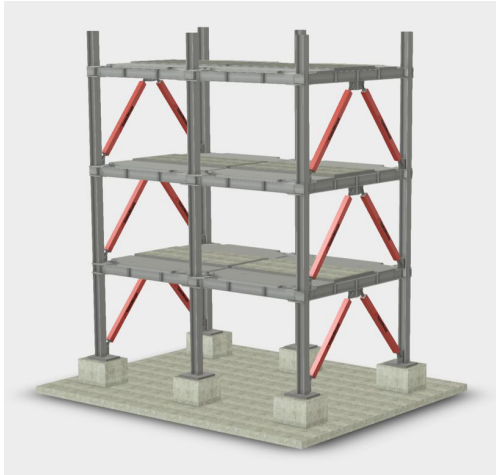
The MTB2 is one-bay by two-bays in plan, and three stories tall (Fig. 2). In the one-bay direction, the building has buckling-restrained braces (BRB). In the two-bay direction, the frames can be configured as either moment frames or as buckling-restrained braced frames. This allows the MTB2 to simulate a variety of structural systems. The moment frame configuration employs DuraFuse Frames®, since the DuraFuse connection is the only prequalified fully-restrained connection that is easily repairable.

Fig. 2. Modular testbed building (MTB2).

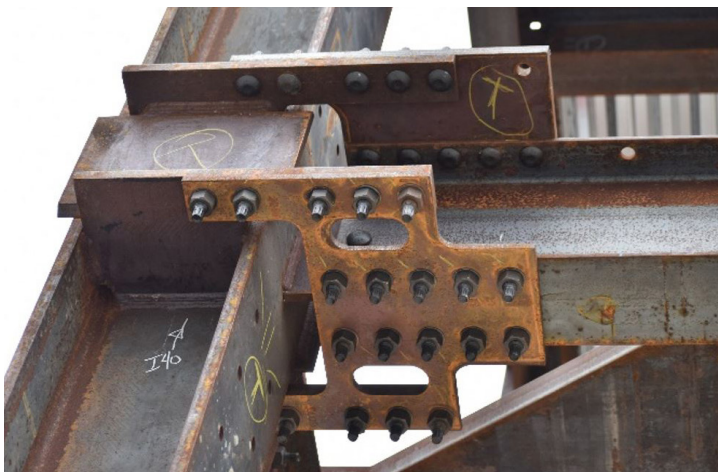
Member sizes were selected for the MTB2 so that the stiffness and natural frequencies of the MTB2 would reasonably represent actual three-story steel structures. The columns were W12×96 and the beams were W14×34. The W14x beams were used to be in proper proportion to the bay length. Figure 3 shows the fuse plates at one of the beam-to-column connections. The fuse plates were ½ inch, A572 Gr. 50 steel.

Fig. 3. DuraFuse connection in the MTB2.

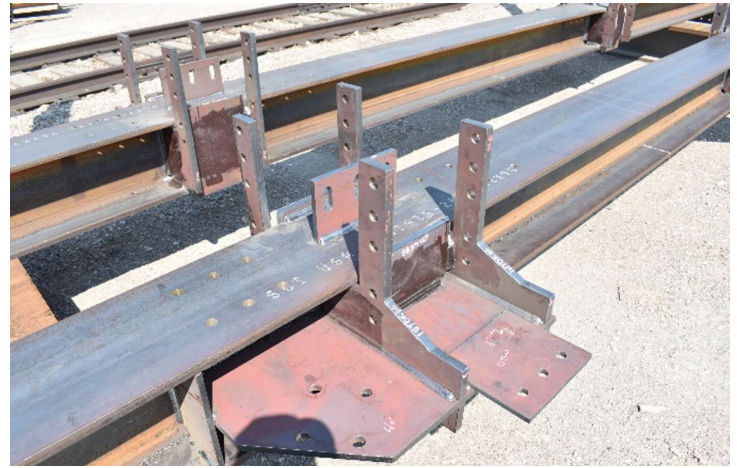
The corner columns in the MTB2 were used for the braced frame in one direction and moment frame in the other. A special DuraFuse connection detail was used for this bi-axial condition (Fig. 4 shows a column prior to erection). A similar detail has been used on other building projects that involve both DuraFuse Frames and buckling-restrained braced frames.

Fig. 4. Bi-axial column detail for the MTB2.

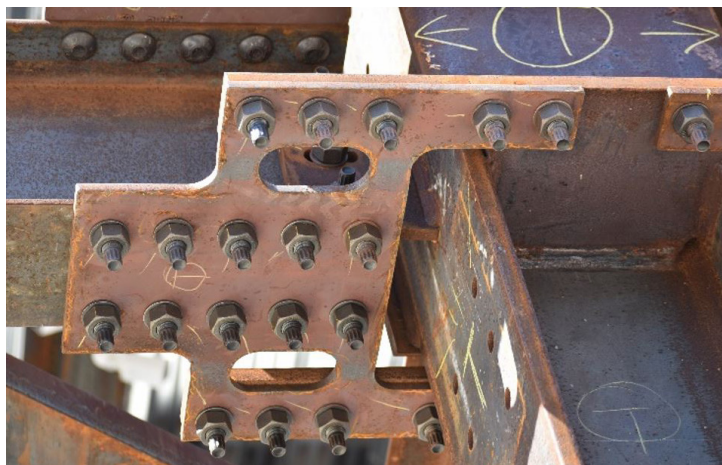
The DuraFuse Frames performed as expected during the earthquake shaking. The maximum drift experienced by the MTB2 frame was almost 2%, which is similar to the design story drift for many moment frame buildings. There was no yielding in the beams, columns, or panel zones and there was no damage to welds. The fuse plates experienced yielding, as evidenced by flaking of the mill-scale, but had more-than-sufficient capacity to resist multiple severe events (Fig. 5).

Fig. 5. Fuse plate yielding during severe earthquake shaking.

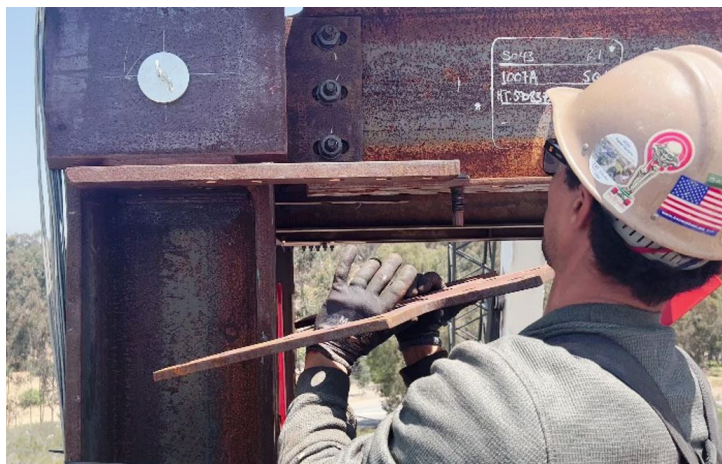
After the twenty earthquakes, the fuse plates were removed so the MTB2 could be prepared for the all-BRB configuration. There was no difficulty in removing the fuse plates. The bolts were loosened with a torque wrench and then removed by hand (Fig. 6). The fuse plates were replaced with bolted gusset plates to receive the BRBs. The bolted gusset plates used the same beam holes as the fuse plates. The frame was able to accommodate the installation of the bolted gussets and BRBs without the need of cables for replumbing.

Fig. 6. Fuse plate removal after testing.
