TECHNICAL BULLETIN 26

Criteria for Replacing Fuse Plates after a Severe Earthquake

Paul Richards, PhD, PE¹

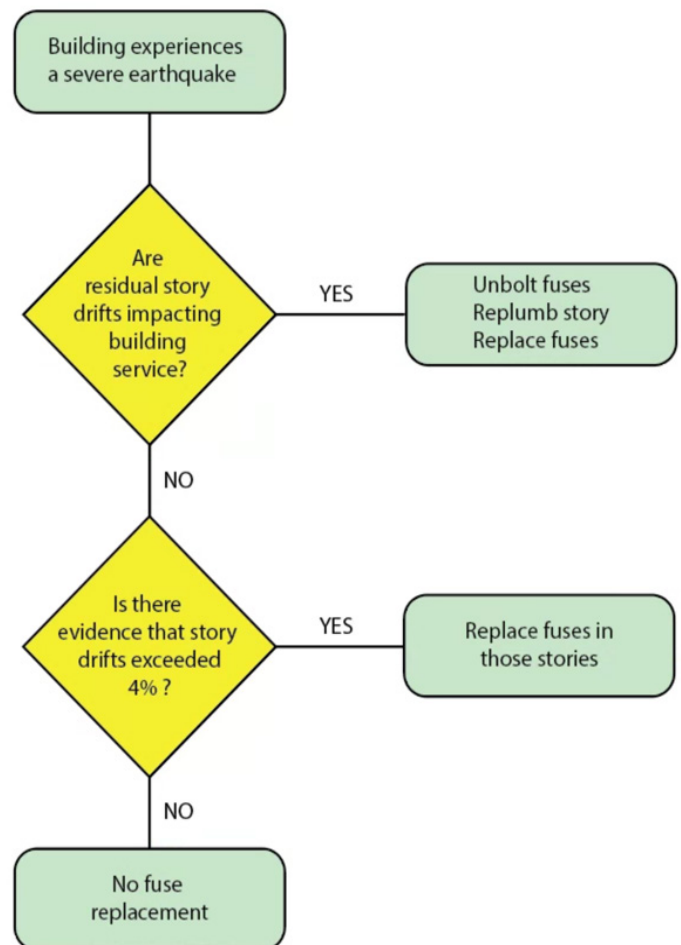
The flowchart in Figure 1 can be used to determine if fuse plates need to be replaced in a particular story of a building. The first question is: “Are residual drift story drifts impacting building service?” Since this is a serviceability question it can be answered by a non-engineer. If residual story drifts are impacting building service, fuse plates in the effected stories should be unbolted, the stories re-plumbed, and new fuse plates installed.

Fig. 1 Flowchart for post-earthquake assessment of fuse plates.

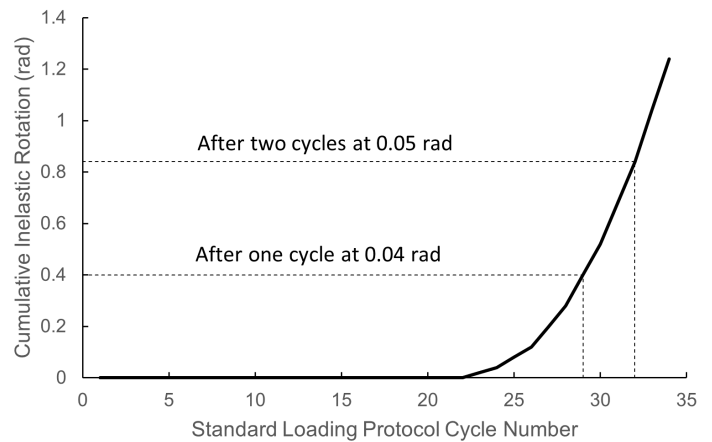
Figure 5 shows the cumulative inelastic rotation that is experienced by a connection tested under the standard AISC moment frame loading protocol (assuming 1% elastic rotation). By the qualification limit (one cycle at 0.04 rad), the cumulative inelastic rotation demand is 0.4 rad. DuraFuse Frames specimens have completed two cycles at 0.05 rad or one or two cycles at 0.06 rad prior to fuse plate fatigue (Richards 2022). Figure 5 illustrates how this represents more than double the cumulative inelastic rotation capacity that is required to resist the event represented by the standard loading protocol up to 0.04 rad. Therefore, it is reasonable to judge that a fuse plate has sufficient capacity to resist another design-level earthquake, as long as there is no evidence that a previous earthquake has caused story drift greater than 4%.

Fig. 5 Cumulative inelastic rotations from the standard special moment frame loading protocol (assuming elastic rotation of 0.01 rad).
